Ensuring the Stability of the Washington Monument Foundation

August 26, 2011

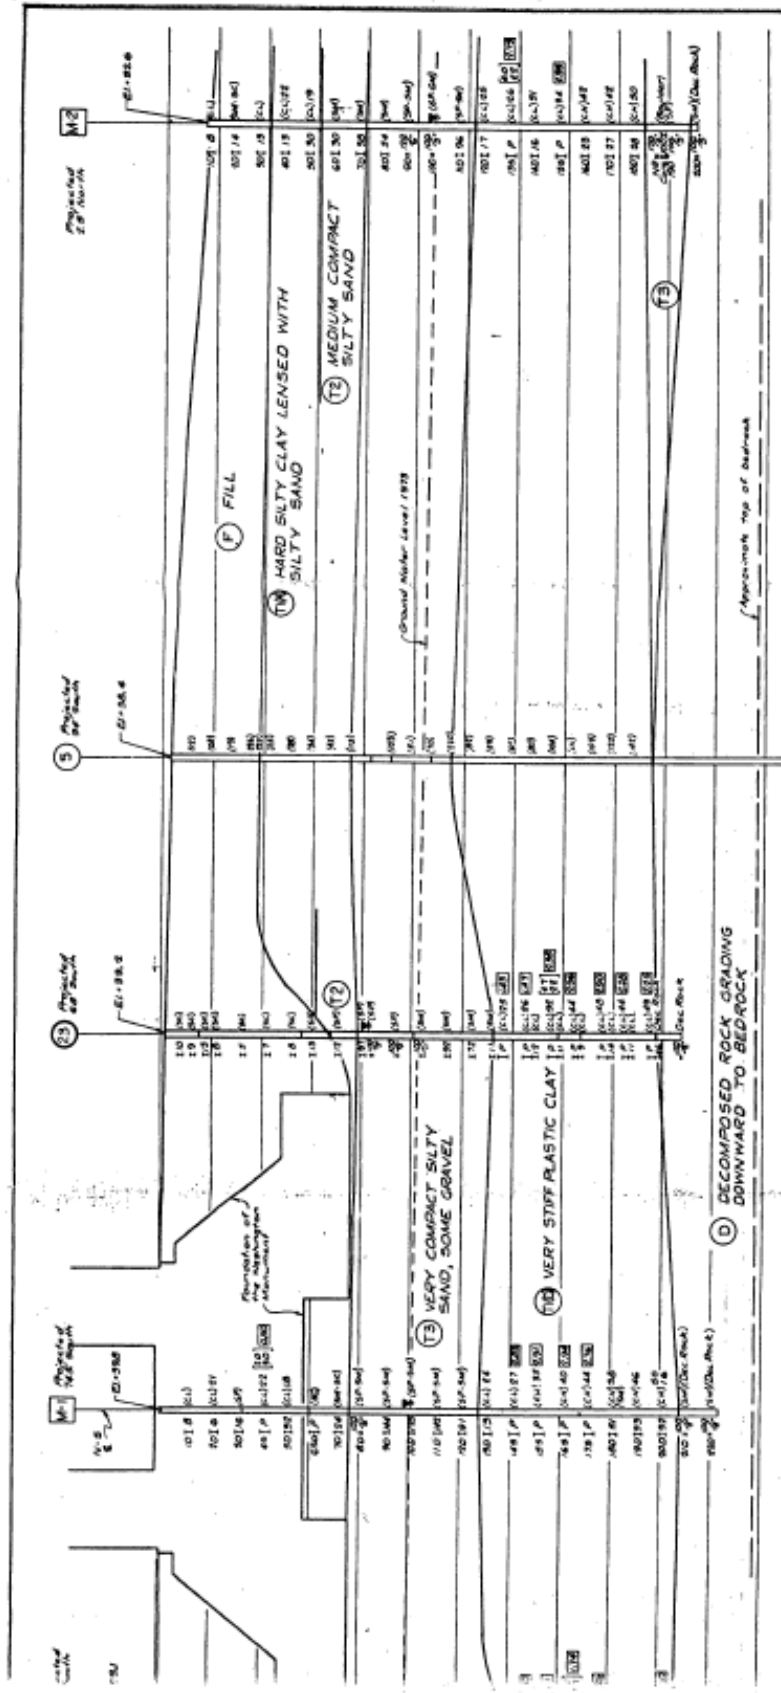
EAST - WEST GEOLOGICAL SECTION GS-2

- A description of subsoil conditions and settlement comes from a letter of February 13, 1984 from Mueser-Rutledge-Johnston-&-Desimone Consulting Engineers to William F. Ruback, Superintendent, National Park Service, National Capital Parks – Central [since renamed National Mall & Memorial Parks]: “The Monument is underlain by stream terrace deposits of Pleistocene times, directly over bedrock. The Pleistocene materials range from a medium plastic and slightly to moderately organic clay, to a very compact mixture of sand and gravel with some boulders. **It is the presence of a layer of this clay, designated Stratum T-1 (D), which has occasioned concern about stability of the Monument** [emphasis added]...The Magnitude of settlement that has occurred between 1898 and the late 1960’s is consistent with an appropriate theoretical rate of secondary compression of the underlying soil strata. The increased rate of settlement that has occurred since the late 1960’s is very probably due to an effective increase in overburden stress as a result of lowering of the ground water level in the general area by construction activity. Following extensive development in the Mall, involving deep basement excavation and depressed roadways, there has been a widespread drawdown of groundwater in the range of ten to 15 feet. The Mall area between 12th Street and the Monument has been dewatered to an appreciable extent by the construction along 12th Street.” See below the cross section showing the substrata.

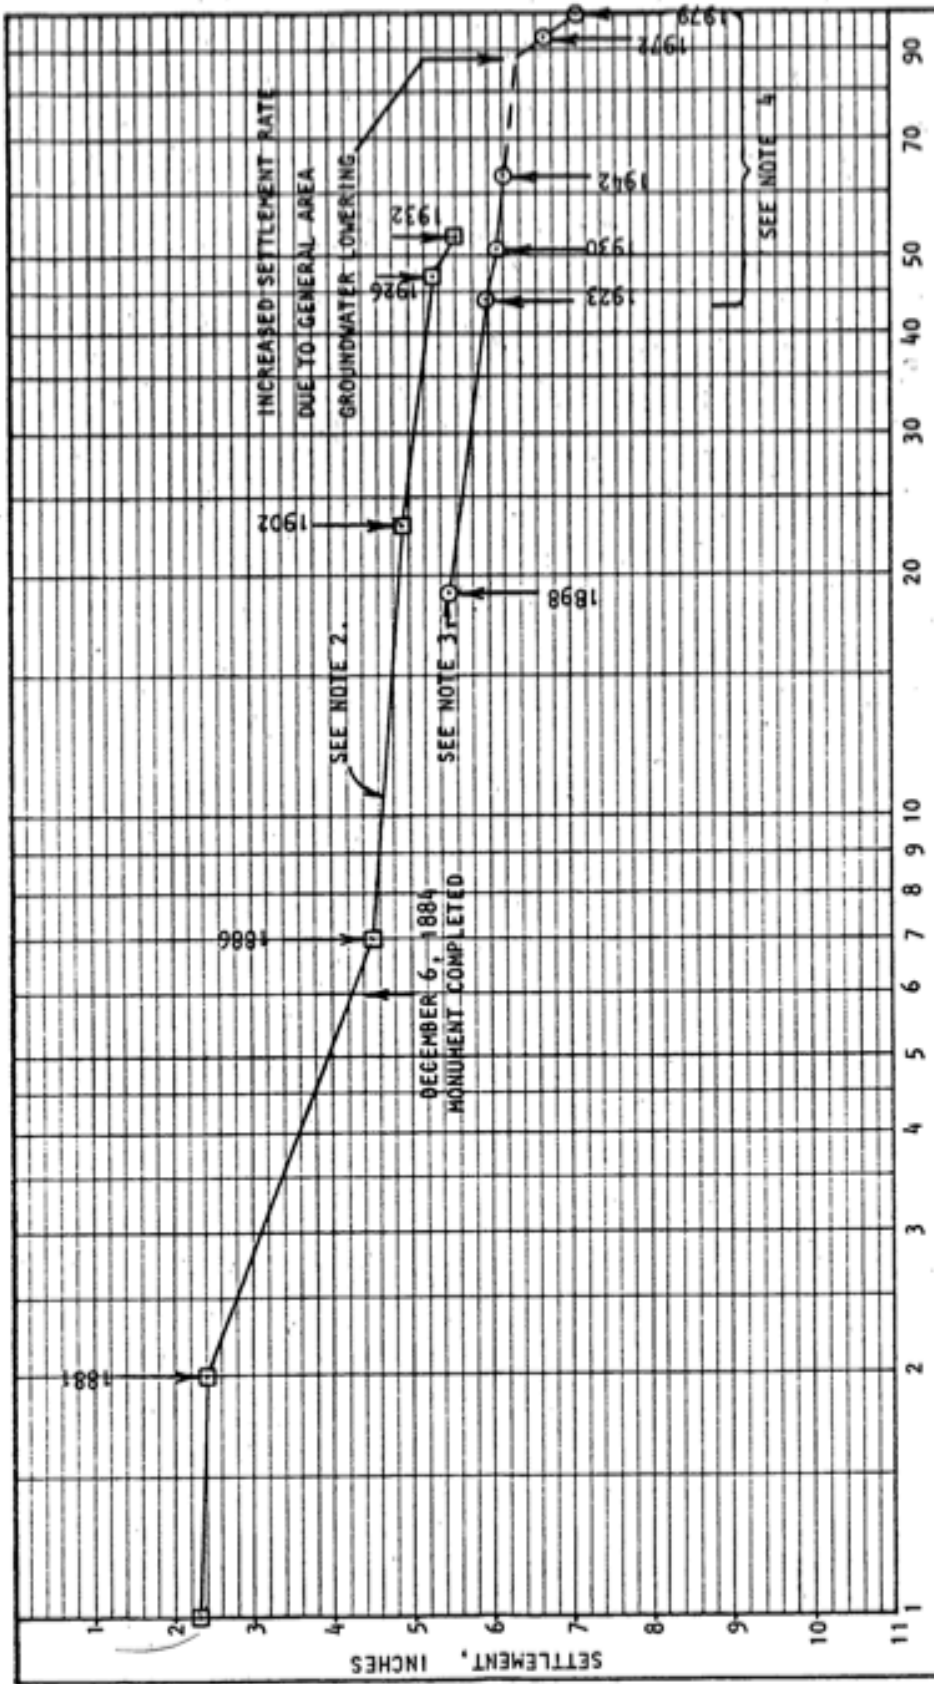
PLATE NO. 1

"The increased rate of settlement that has occurred since the late 1960's is very probably due to an effective increase in overburden stress as a result of lowering of the ground water level in the general area by construction activity."

- This 1984 report includes a graph that shows an **"increased settlement rate due to general area groundwater lowering"** between 1962 and 1979. See the graph below.
