**Comments on behalf of the Committee of 100 on the Federal City
Regarding the November 8, 2010 National Park Service
Presentation of Options for the Design of Security Improvements at
the Washington Monument**

February 24, 2011

By Don Hawkins

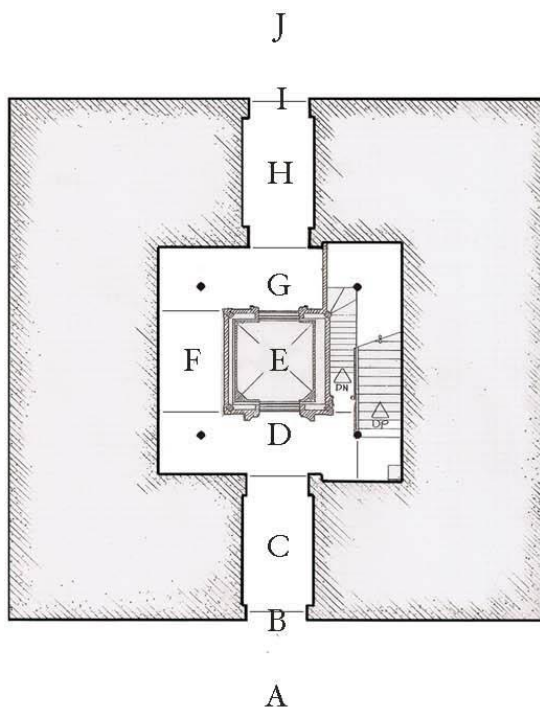
(fig. a)

C100 OPTION "F"

J.) West Plaza

I.) Reopened West Portal Exit

H.) West Vestibule

G.) West Lobby

F.) Security Monitor Station

E.) Elevator

D.) East Visitor Waiting Area

C.) East Vestibule Screening Area

B.) East Portal Entrance

A.) Visitor East Plaza Waiting Area

The Committee of 100 submitted Option F to NPS in 2002, during the Section 106 consultation process (6a). It calls for screening of visitors within the Monument after reopening the original West Portal. This would require removing some of the marble veneer which was put in place around 1900 and has been damaged by differential settlement. NPS responded to this proposal by changing important characteristics of it to form Option F', and then judged it unworkable (6b). NPS' former reluctance to seriously consider the idea notwithstanding, there can be no doubt that it would be a far easier task to remove a few damaged pieces of marble from the face of the Monument than to tunnel through hundreds of tons of foundation stone and concrete beneath the Plaza. It is equally clear that this return to the West Portal's condition of 1885 would be as easily reversed to that of 2011 as the original closure was. That brings Option F into conformance with the Secretary of Interior's Standards.

Option F (6a) Screening in East Vestibule and exit through reopened West Portal

Visual Effect: Opening the original West Portal would restore a degree of symmetry that had been lost. Marble veneer that has been damaged by settling would be removed.

Visitation Effect: Entering through the East Portal and exiting through the West Portal would allow for the simplest, strongest, and most direct experience of the Monument.

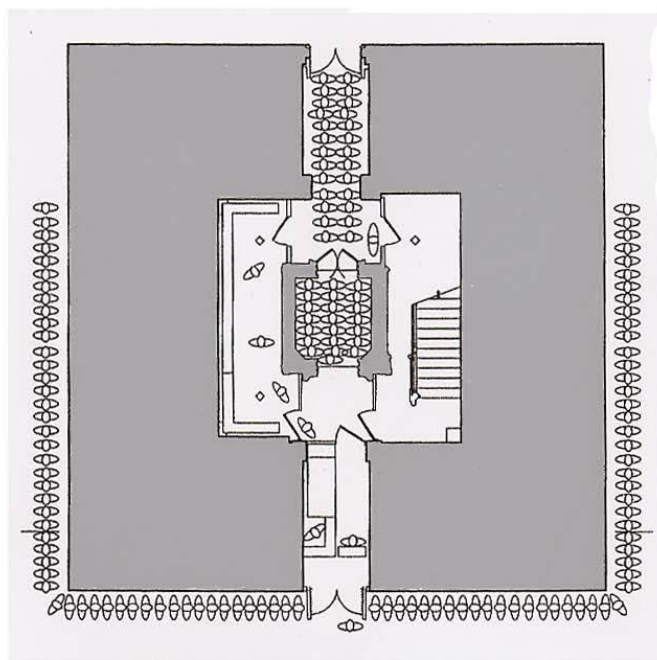
(fig. b)

NPS OPTION "F"

NPS Analysis - C100 Response

1. **Single X-ray and magnetometer rather than two of each**
Existing facility has only one of each
2. **X-ray and magnetometer too large for space 'C'**
Existing devices would easily fit.

3. **Blast doors at exterior would have to swing out. Affects historic fabric & aesthetic quality of facade at 'B'**
Blast doors would open within the structure for no exterior effect.

4. **Insufficient entry space before screening. Main entry doors would have to remain open for each screening session.**
Visitors would enter in small groups as at present.

5. **No queuing space - visitors exposed to elements.**
Same as first century and a quarter and at present
6. **Private screening area is too small.**
Need for more space is unclear and unsupported.

7. **Steel columns are unprotected from blast.**
Columns only support the stairway & are isolated from blast area.
8. **Ranger area and stair would need blast protection**
This could easily be done

9. **Historic fabric at west facade would be affected.**
It would be restored to its 1884 condition.
10. **Visitors must wait in elevator for screening time.**
Visitors would await elevator in East Lobby 'D'

11. **Space for only one guard at screening area.**
Not true, but screening could be monitored remotely.
12. **Elevator time period would be increased due to use as holding area.**
Visitors would wait in the lobby as at present

Option F' (6b) Screening in East Vestibule with modified distribution of Spaces

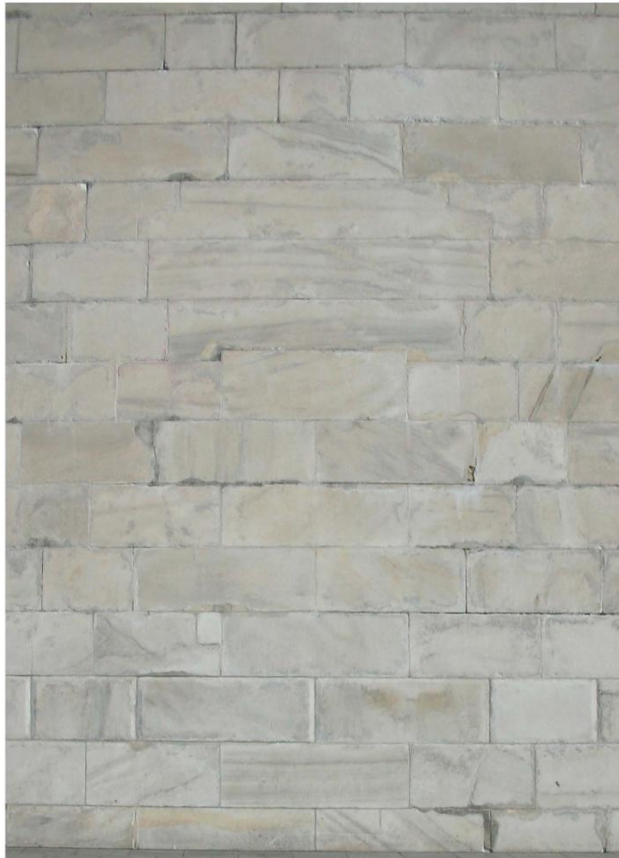
(a)

EXISTING WEST PORTAL AREA

In his quest for geometric purity, Casey even removed the already-carved Egyptian motifs from around the portals. He left only the four pairs of windows at the viewing level and the pair of portals at plaza level to disturb the abstract purity of the obelisk. In his hands the openings became simply absences of material in the smooth marble surfaces, and both portals remained open for some years after Casey delivered the Monument as a completed artifact. About a decade later the West Portal was closed. When both doors were opened at the same time powerful drafts had been troublesome, especially to ladies wearing large skirts. An attempt was made to efface the evidence of its former existence, but the shape of the Portal may still be discerned on the west face of the Monument, framed by fractures through the marble veneer (7a, 7b).

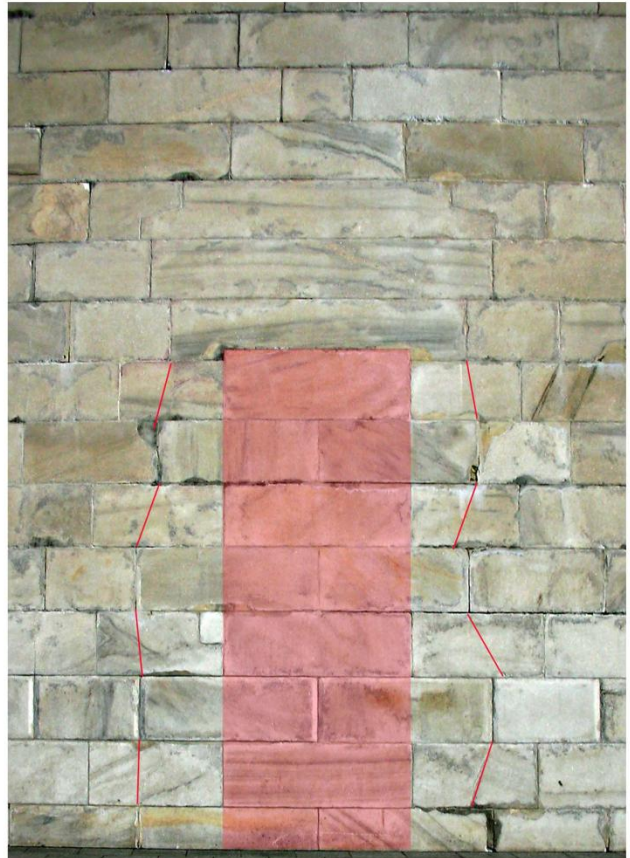
(b)

ENHANCED WEST PORTAL IMAGE
ORIGINAL MASONRY OPENING SHADED
RED LINES INDICATE SETTLEMENT FRACTURES

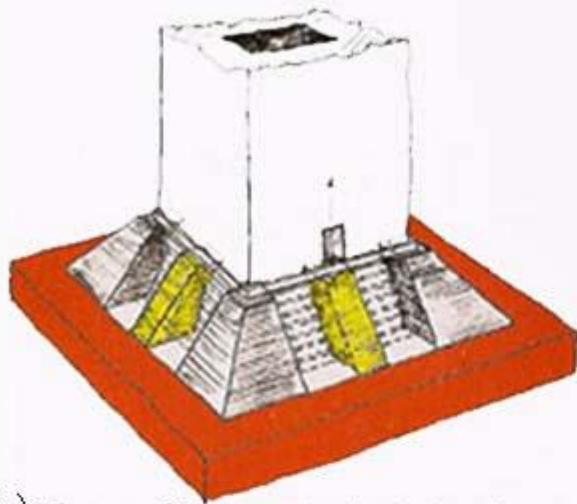
(a) Diagram of Monument underpinning plan.

Beneath the Plaza, the Monument's foundations encapsulate the story of the maturing of American engineering. Casey began to study engineering at West Point at the very moment when the Washington Monument Society began construction on the naïve original foundation he would learn to correct and stabilize (9b). Uneven subsidence had already tipped the abandoned structure by the time he undertook its completion thirty years later. Buttresses and additional footings were installed, with great care taken to balance and resolve the gigantic forces at play. Gross quantities of materials needed to be dis-placed and re-placed with great delicacy over an extended period of time (8a, 8b, 8d). In its own grand symmetry, it was a major feat of engineering. The photographic record brought forward by NPS allows us to appreciate the simple magnificence of its final form, much too easily forgotten after its completion and burial in 1880, never to be seen again (9a).

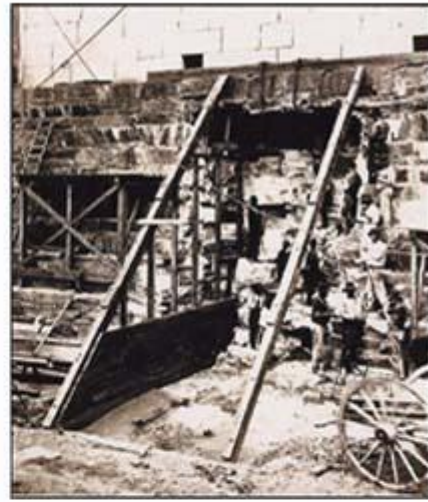
(b) Buttress Construction 1879

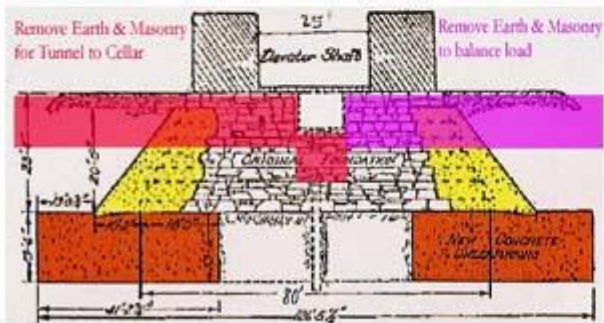
(c) Diagrammatic Section Showing Excavation Through Buttresses and Foundation

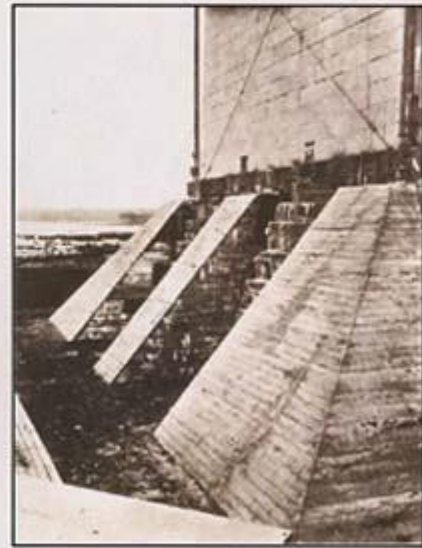
(d) South Buttresses

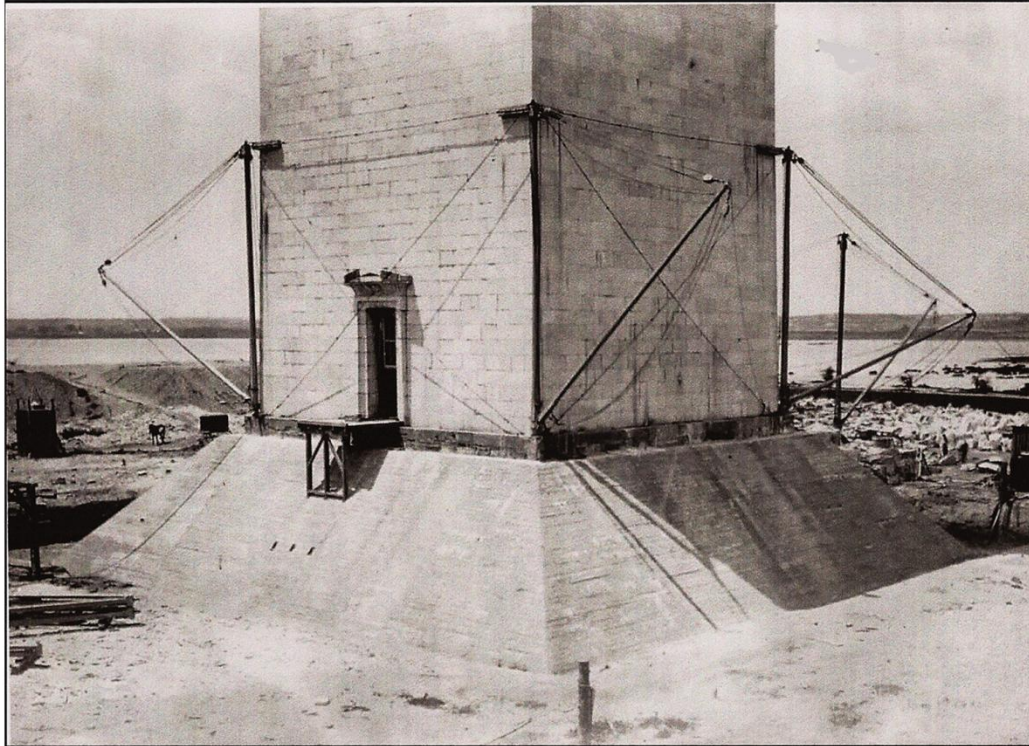
Foundation of Monument in 1880 as Completed by Lt. Col. Casey

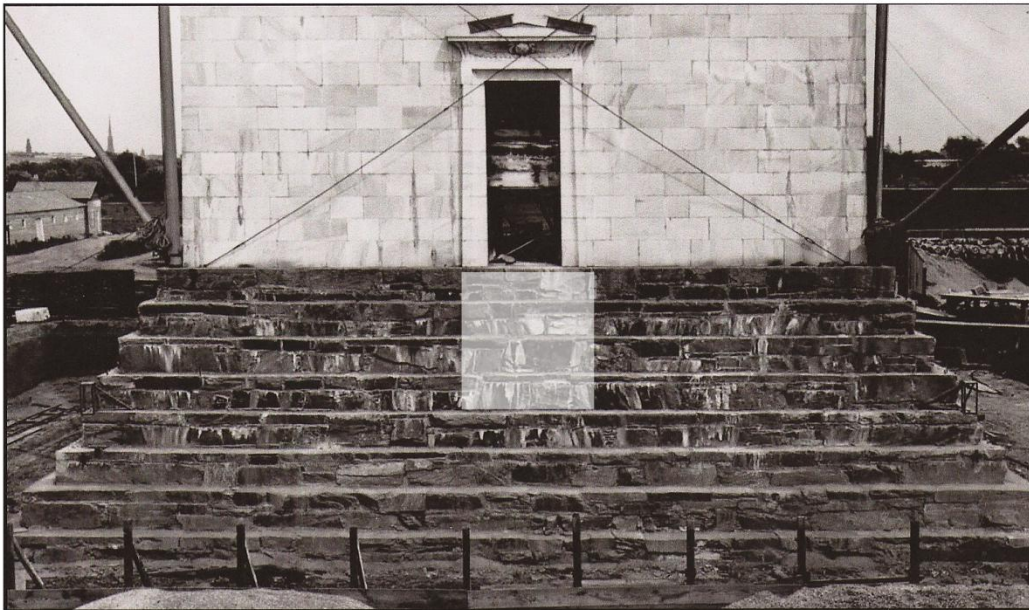
West Portal prior to closure with marble veneer & removal of ornaments and Robert Mills foundation showing minimum opening required for cellar access
